NGEE ANN
POLYTECHNIC

**PERFORMANCE TESTING OF BIONIPERFORM
COATING**

EVS0010
(IVS1022)

22 January 2010

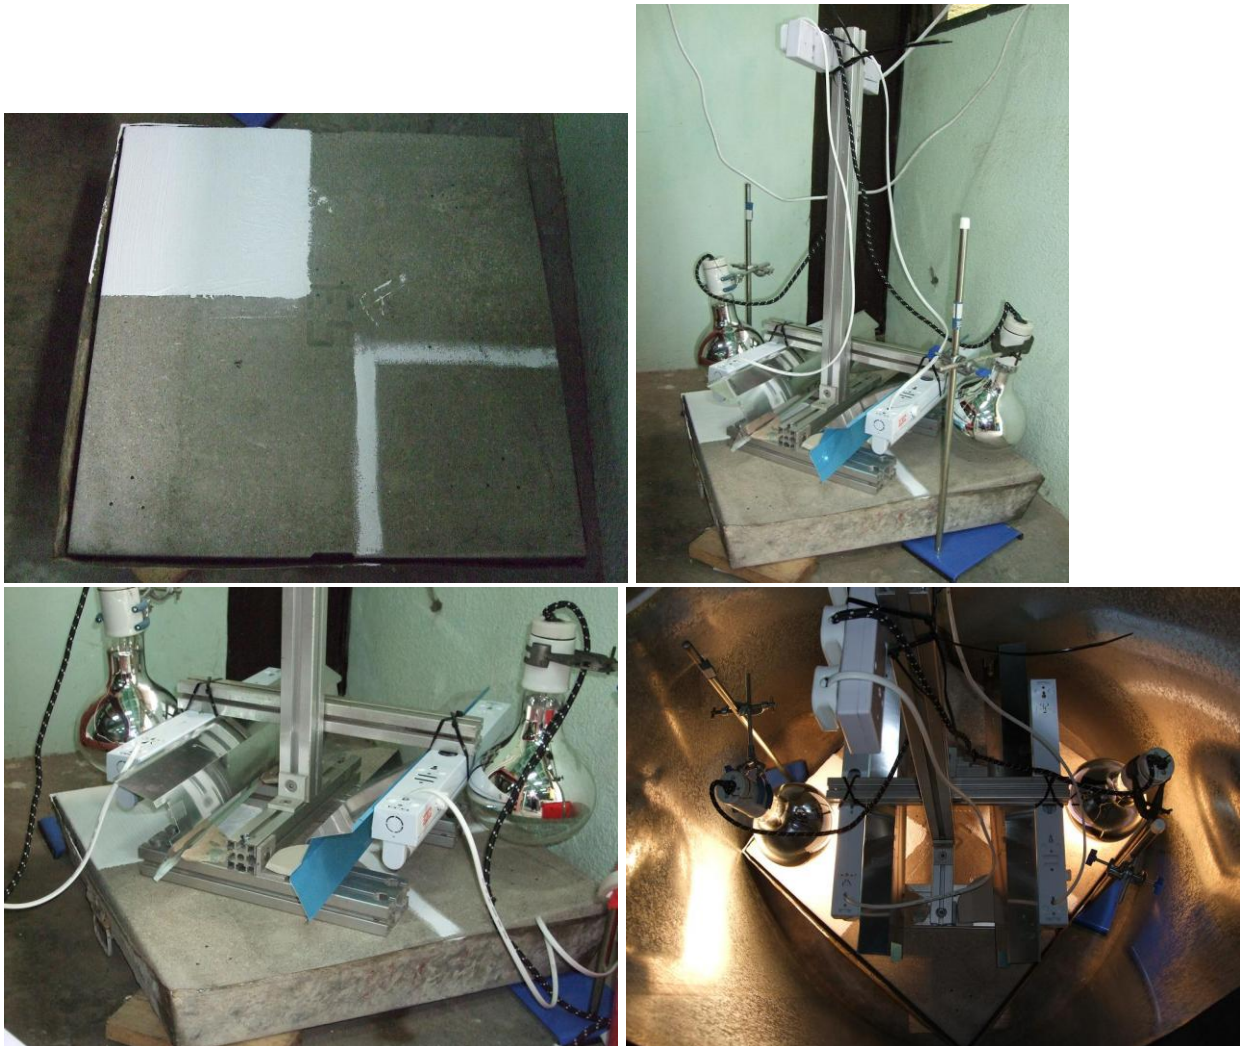
The accelerated ageing system was set up using guidelines from ASTM G 154-06 [1]. The weathering conditions of water, rainwater, UV light, and infrared light were used to ascertain the effects of aging. The ferrocement slab was placed in an iron tray and rested on a 10 cm thick sponge to compensate for unevenness in the bottom of the slab and ensure that there is full contact with water during the testing. A 1 mm thick Coating was painted on a square-shaped corner of the slab whilst an identical square in the opposite corner was used as the control uncoated sample which will be subjected to the same test conditions. See Figure 1 for the setup.

Fig.1. Accelerated ageing system.

Two identical UV tubes (UVA-340, 15W)¹ with reflective covers were located 5 cm above the square zones in such a manner that both zones received uniform irradiance, as shown in Figure 1.

Two identical incandescent bulbs (500W) were supported 4 cm above the centers of the square zones respectively to provide the same radiative intensity to the zones. The surface temperatures were monitored by an infrared thermometer (Raynger ST6, Raytek).

The tray was filled with water and the water level was maintained so as to provide constant moisture to the slab. The sponge at the tray bottom helped to retain the water and prevent rapid evaporation and to render a complete contact between the water and the bottom of the slab. In addition, rainwater collected in the vicinity of the test site was sprayed every other day on the surfaces of the slab.

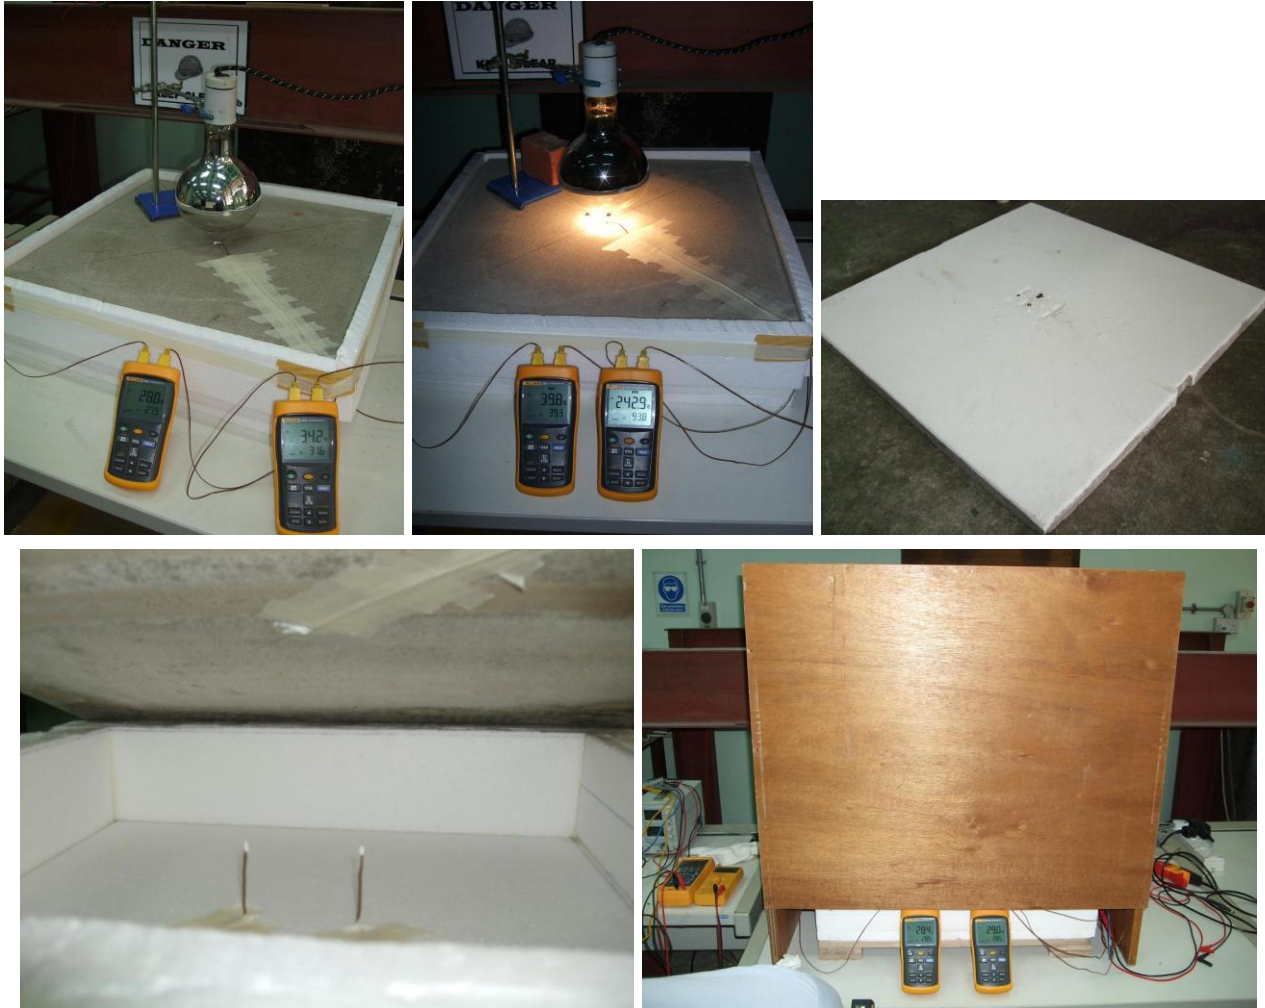
This system comprised an open styrofoam box with the same size of a ferrocement slab, an incandescent bulb (500W), three thermocouples, two digital thermometers and a wooden enclosure. As shown in Fig.2, the non-coated ferrocement slab was placed in the styrofoam box, with an incandescent bulb fixed centrally at 5 cm above the slab surface. The sides of the slab were covered with styrofoam to prevent heat dissipation. The bulb heated up the surface and the heat was transferred into the styrofoam box by conduction, convection, and radiation through the slab. To measure the temperatures at the slab surface and inside the styrofoam box, one thermocouple was attached to the top surface at the center of slab and two thermocouples were placed at the center of the styrofoam box. During the test, the system was shielded by a wooden enclosure to prevent external disturbance. The real time temperature data was recorded by the digital thermometers. The sampling frequency was every 15 seconds and the test lasted for 2 hours.

Fig.2. Thermal insulation testing system.

The same process was repeated using a coated slab which was painted with a 1mm thick Coating on the complete top surface. The temperature profiles of the two tests were plotted and analysed.

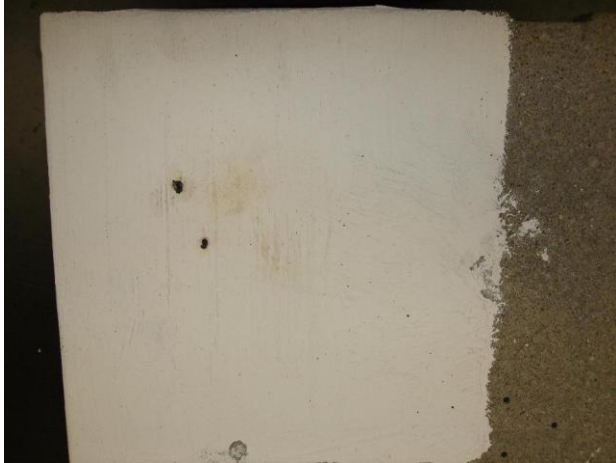
After 25 days exposure in the accelerated ageing system, the ferrocement slab was removed for visual inspection. The appearance of the Coating had no significant change as shown in Fig.3 (a). The Coating was then removed using solvent and water to expose the ferrocement (Fig.3, (b)). The differences in morphology of the coated and non-coated zones are shown in Fig.3.

(a) Coating after ageing

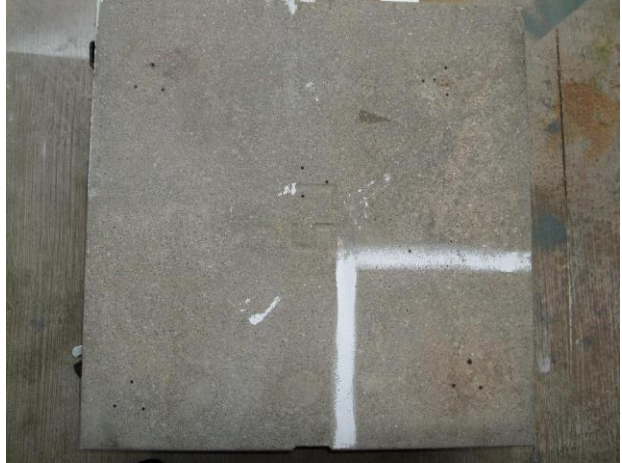
(b) After removal of Coating

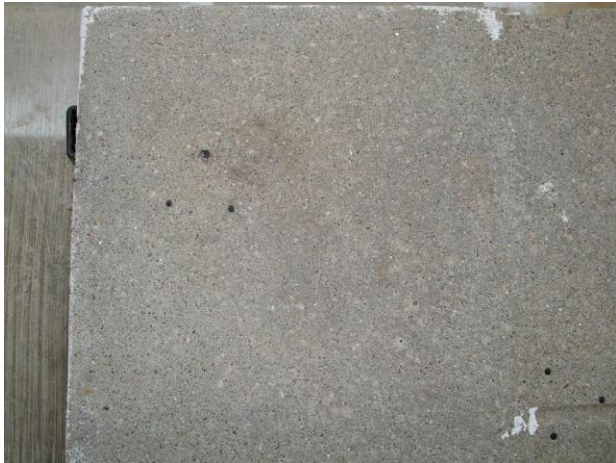
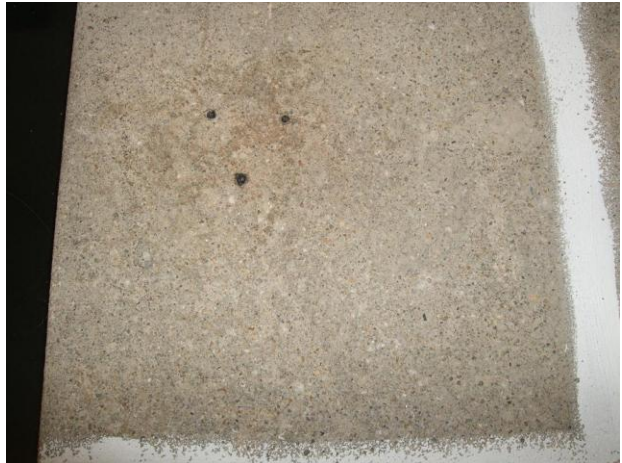
The two tested zones showed significant differences after ageing. As shown in Fig.3 (c), (d), (e), and (f), the area with Coating has a lighter color and a smoother surface than the area without Coating. These changes in coloration and surface texture are consequences of the erosion of cement caused by rainwater, UV light, and heat and the exposure of sand particles in the slab. It appears that the Coating can retard the surface erosion rate of the ferrocement. This observation supports its claim on waterproofing characteristic and resistance to surface temperature.

(c) With Coating

(d) Without Coating

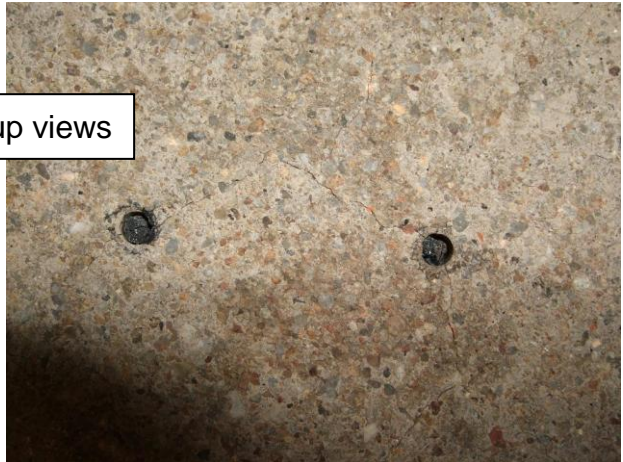
In addition, as shown in Fig.3 (e), (f), (g), and (h), the non-coated area exhibits some cracks in both the surface and the side of the slab, while the coated area has no visible crack. The cracks can be attributed to the effects of the cyclical thermal expansion and the erosion of cement. As the Coating can tolerate high surface temperatures and consequently protect the internal area of the ferrocement slab from temperature effects, it is likely that it can also reduce the thermal expansion damage and prevent cracking.

(e) With Coating

(f) Without Coating

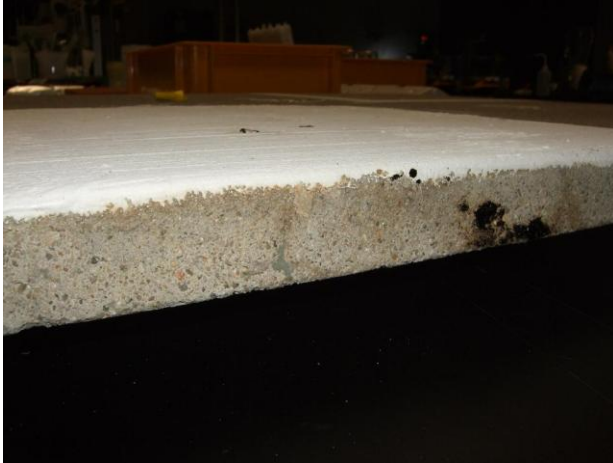
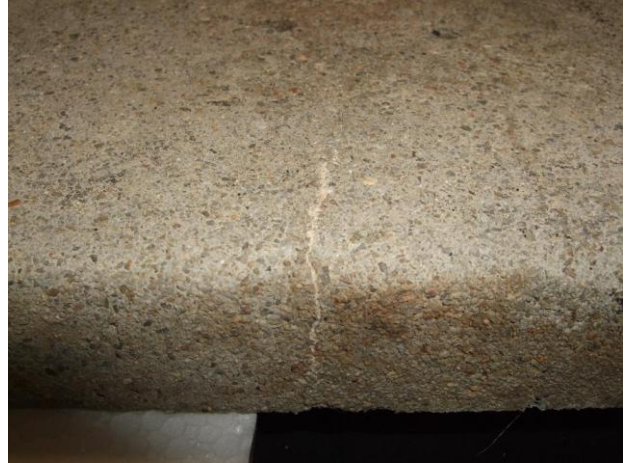
(g) With Coating

(h) Without Coating
